Journal of Civil Engineering and Urbanism

### **Condition Assessment of Metsimotlahe River Bridge using Non-Destructive Testing and Non-Contact Procedure**

Metsimotlhabe Bridge, constructed in 1979, is located at approximately 18 km from Gaborone on the Gaborone– Molepolole Road (A12 route) in the Kweneng District of Botswana. The bridge provides a passable river crossing at all times over the Metsimotlhabe River. The road is a strategic route from the Gaborone, the country's capital and ultimately connects with the A2 road which is a trade corridor passing through Botswana and connecting South Africa and Namibia. The road carries a substantial amount of traffic, but financial constraints have delayed the upgrading to a dual carriageway. The estimated annual average daily traffic in 2020 was 9508 vehicles.

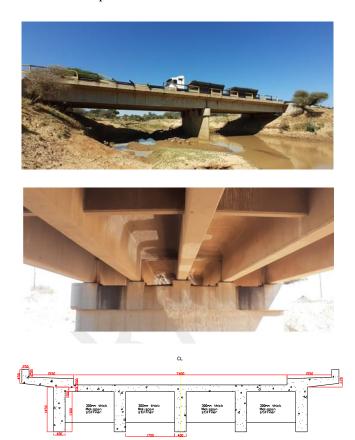
The bridge consists of two spans simply supported RC beam and slab supported on a wall type solid pier. The total span is 42.6 m and total width is 12.1 m. There are 1.5 m wide walkways on either side of the roadway with steel railing parapet. Each span length is 21.3 m comprising five girders spaced at 2.1 m centers. The width and overall depth of the girders are 400 mm and 1500 mm respectively. There are two wall type abutments and RC wall pier. Deck construction method is cast in-situ on stationary false work and the bearing type is elastomeric, teftlon and stainless-steel plates. The vertical alignment of the bridge is at a constant gradient of 0 to 2%, horizontal alignment is straight, camber/cross fall is 2 to 4%, and the angle of skewness is zero degree. Minimum vertical clearance is 6.5 m and the bridge altitude is at 900 m above mean sea level. The surface on deck and approaches is asphalt. Figure 1 illustrates the bridge elevation, underside and profile section.

Figure 1. The elevation, the underside view and crosssection of Metsimotlhabe Bridge

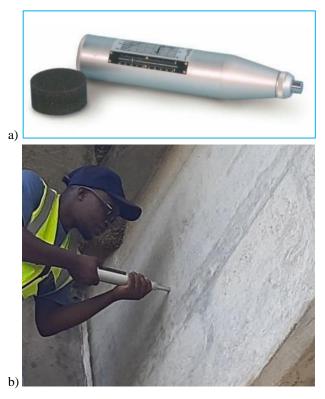
The effectiveness of Schmidt hammer in determining concrete compressive strength of the bridge superstructure was implemented in accordance with EN 13791 (2007) and EN 12504-2 (2021). The impulse test hammer (rebound hammer) is a simple, quick and inexpensive to use and was calibrated with a total of 36 precast concrete cubes of different predetermined compressive strengths between 20 and 35 N/mm<sup>2</sup>. The N Type MH-75 model Concrete Test Hammer (Schmidt Hammer) was used as shown in Figure 2 together with the on-site test process. Prior to field test, the rebound hammer was calibrated to establish the relationship between compressive strength and rebound number.

**Figure 2.** (a) N Type concrete test hammer and (b) on-site test process
